Case 259 : Narrative

Case Vehicle (A): 1998 Mercury	Vehicle (B): 1997 Mazda
Type: Villager GS, 4x2 van	Type: 626, 4-door sedan
Driver: 36-year-old male	Driver: 18-year-old male
CDC: 11-FLEE-2	CDC: 99-0000-0

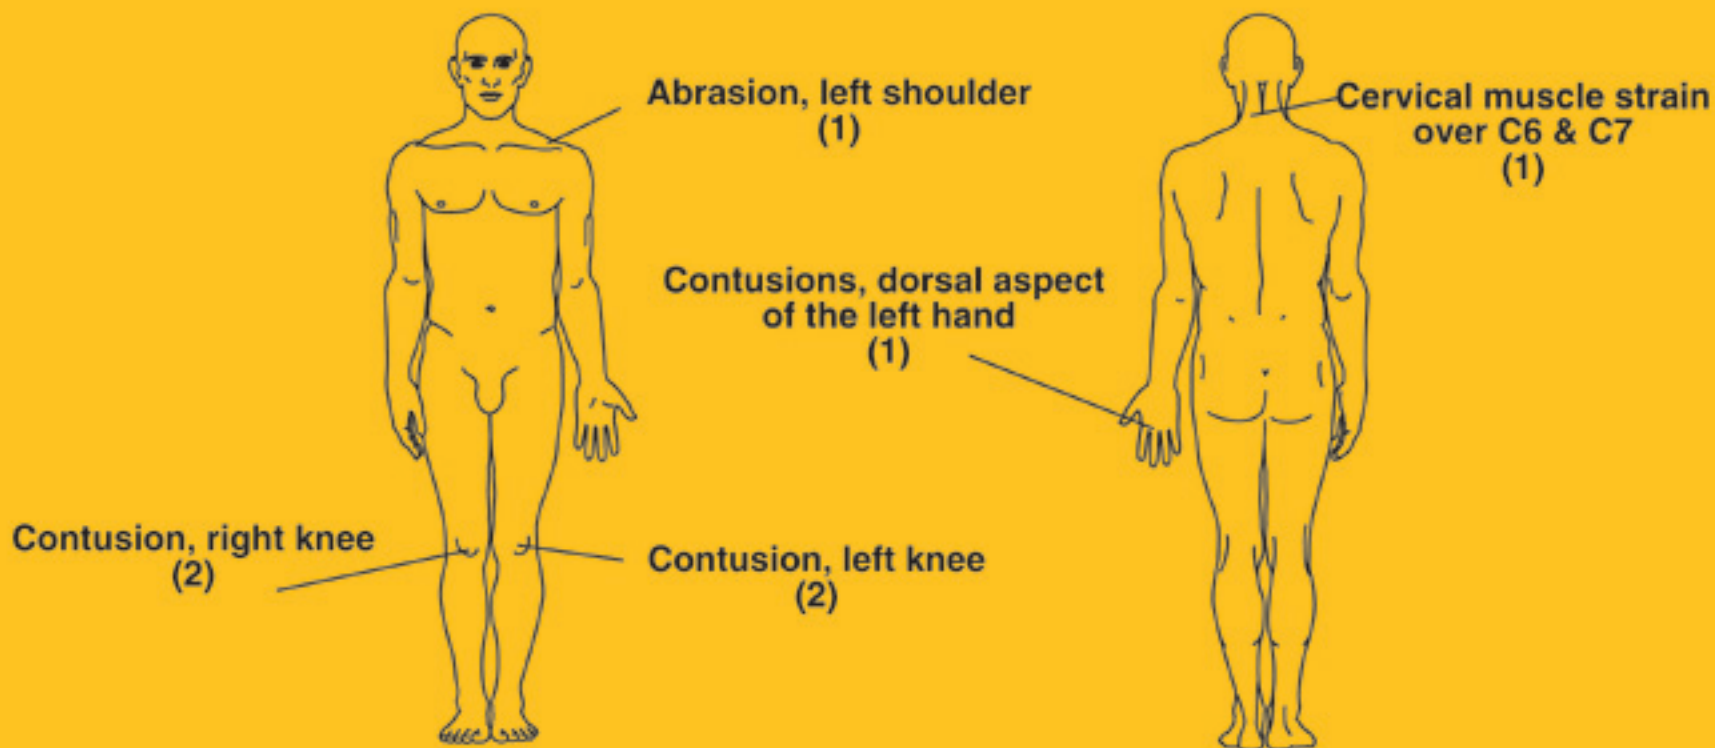
The following table [46](#) and attached drawing summarize the injuries for the driver.

Occupant: Driver	Age: 36 years	Gender: Male		
Restraints: 3-point belt worn; airbag deployed	Stature: 180 cm (5 ft, 11 in)	Mass: 82 kg (180 lb)		
Injury Description	A.I.S.	Injury Source		
—	—	Definite	Probable	Possible
Cervical muscle strain over C6 & C7	1	—	Impact forces	—
Abrasion, left shoulder	1	Shoulder restraint	—	—
Contusions, dorsal aspect of the left hand	1	—	Cruise-control switch cover	—
Contusion, right knee	1	Knee bolster	—	—
Contusion, left knee	1	—	Hood latch lever, emergency brake pedal	—
Maximum A.I.S. Level	1	—	—	—
Injury Severity Score	2	—	—	—

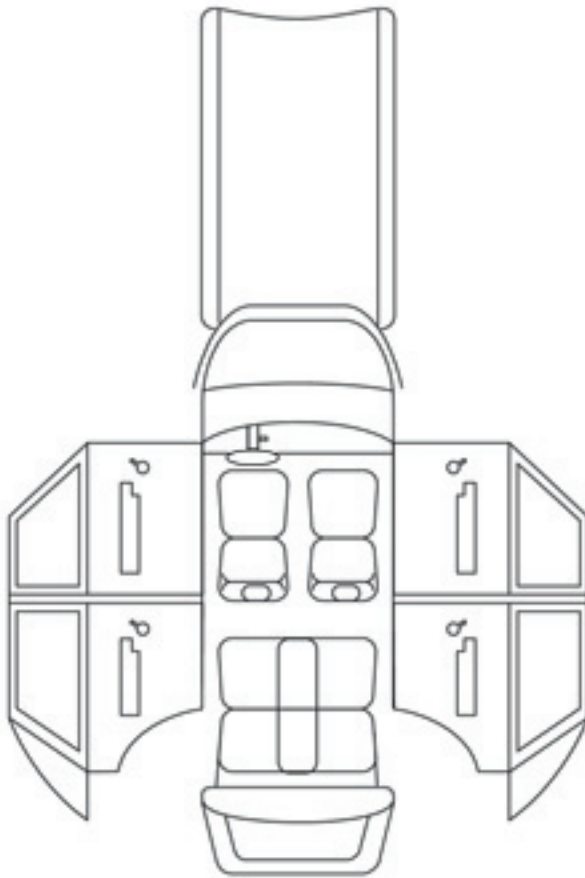
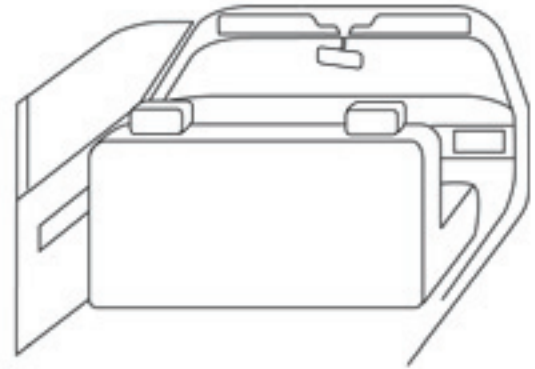
Dr Belt- evidence of use:
black on webbing from D-ring
scratches on D-ring

belt positioned low on B-pillar
